Location: Highway 32:08 (Approx. 23 km N. of hwy 16)

Applied: October 1999 Evaluated: May 27, 2008

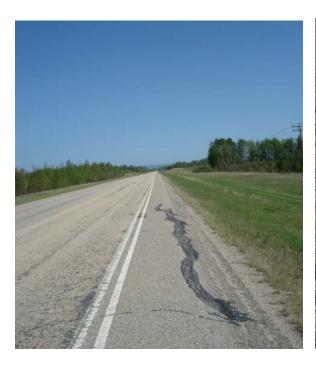
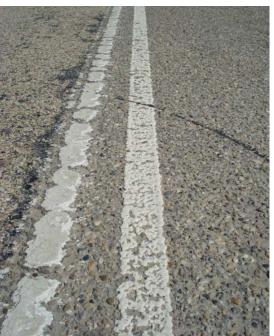
Pathfinder durable wet night marking applied adjacent to the east edge line in 1999. Pathfinder looks very good after nine years with good retro-reflectivity.

This marking was surface applied in 1999 adjacent to the E. edge paint line. There is approximately 10% snowplow damage that was observed. Retro-reflective readings were taken with the 30m geometry and the old 15m geometry for comparison purposes (see the attached retro-reflectivity chart). The difference in the types of retro-reflectivity equipment is approximately 10 millicandelas.

The average retro-reflectivity using the 30m geometry is 93 millicandelas, which is very good after 9 years of service. Traffic volume at this location is low (less than 1000 AADT), a better indication of performance will be on hwy 2 near millet.

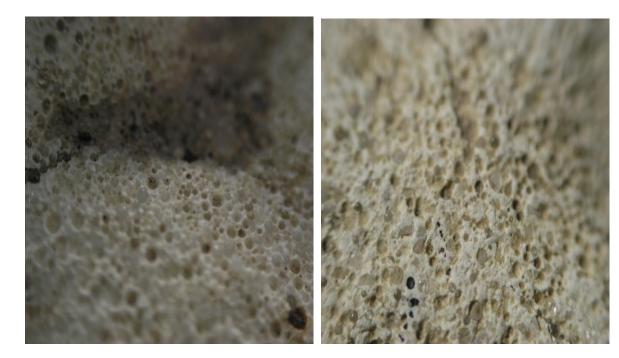
Close-up of the Pathfinder pavement marking using a macro camera lens. I estimate approximately 30% bead retention.
