Pro-Eco-Lite Culvert End Treatment
Trial Product Status
Location: Hwy. 2, W. of Dunvagan Bridge

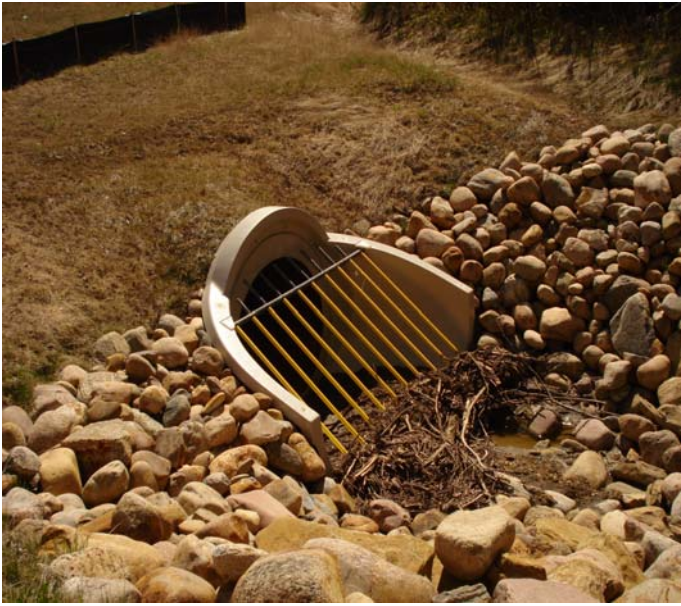
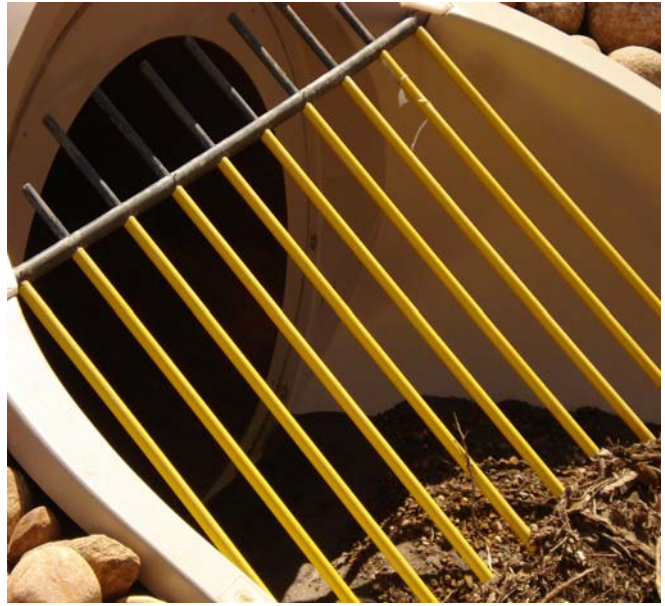
Upstream end, End treatment with grate (1200 mm dia.)

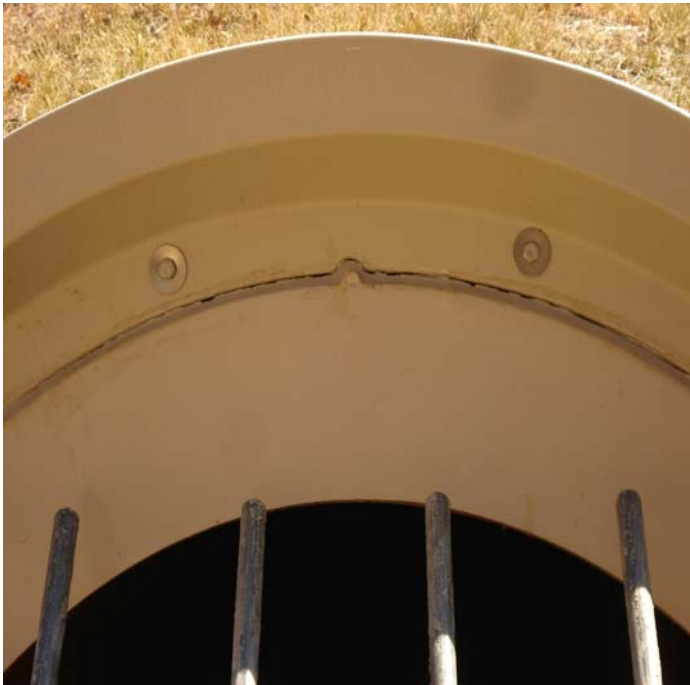
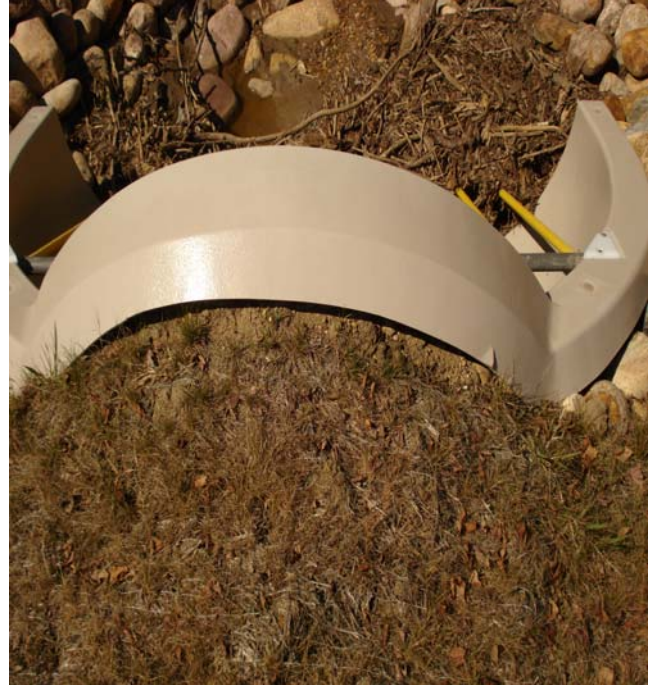
End treatment performing very well

The Pro-Eco-Lite Culvert End Treatment is performing very well at this location. The only problem observed is the build-up of branches on the upstream end. This can be cleared out easily.
