**PRODUCT INSPECTION**

Siplast Teranap Geomembrane	Product ID: 8150-5-1-1 Initiation Date: January 2007 Expiry: February 2010 Status: Trial Inspected by: F. Cheng On: April 6, 2010
-----------------------------	--

Project	Description	Application Date
LNID Canal, South Park Lake	6 km	December 2006

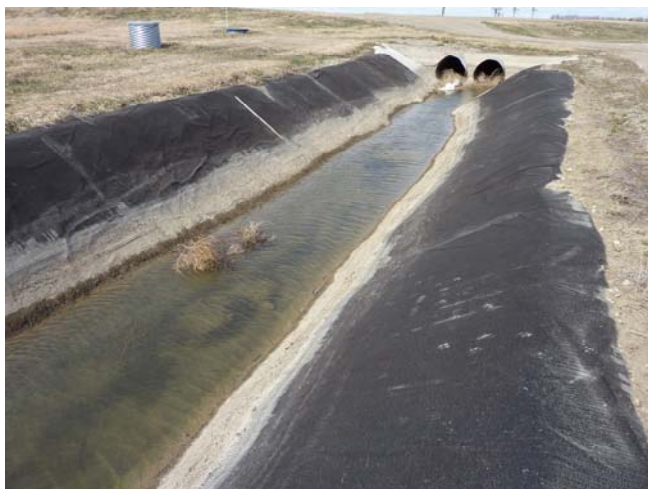
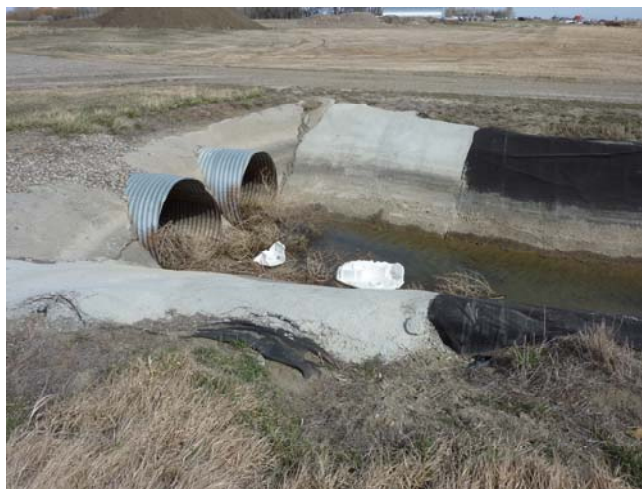
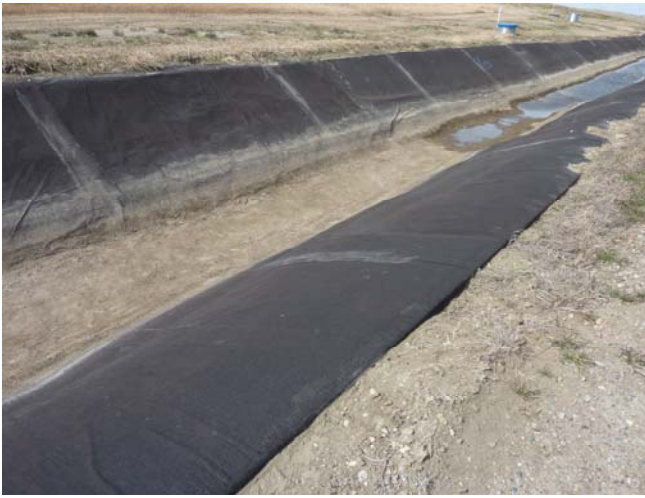
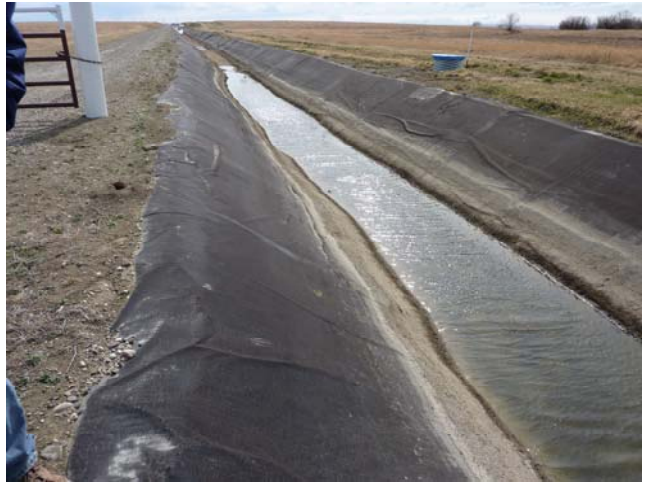
Over the years the concrete lining of the LNID in the South Park Lake has cracked. In 2006, repair work was conducted by installing a Siplast Teranap Geomembrane. After cleaning the debris, patching with concrete, re-setting the concrete blocks and filling the cracks with polyurethane, Siplast Teranap Geomembrane was installed on top of the repaired concrete canal lining. The overlap joints were fused by a propane torch. The geomembrane edges on top of the canal were buried in dirt. Shortly after installation, portions of the liner bubbled and uplifted. It was determined that groundwater seepage had entered the canal. Holes were punched into the lining to release the water pressure. A permanent dewatering system consisting of perforated pipes and pumps was installed and water is pumped back into South Park Lake on a regular basis. The canal owner does not have any complaint of the application of this product. During the inspection in the low water season, the geomembrane was intact and no signs of material failure were found.

The Siplast Teranap Geomembrane does not show signs of failure and joints were intact. It is recommended that the product be advanced to Proven status.
