PRODUCT INSPECTION

Stenlog	Product ID: 8130-2-4 Initiation Date: July 25, 2002 Expiry: December 2009 Status: Potential Inspected by: F. Cheng On: May 27, 2009
---------	--

Old Ferry Road (S. of Jct. H32/H43, Whitecourt)

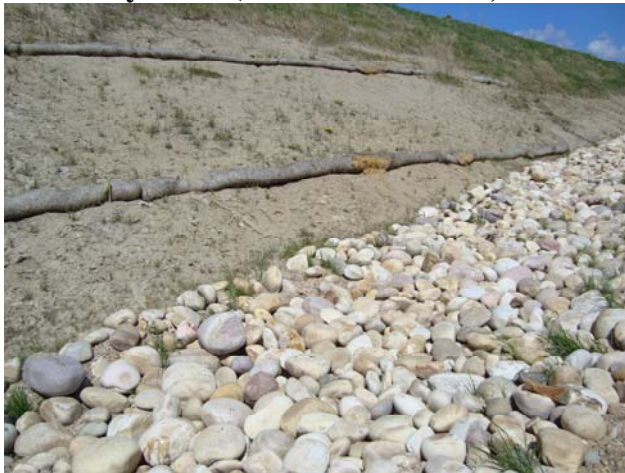
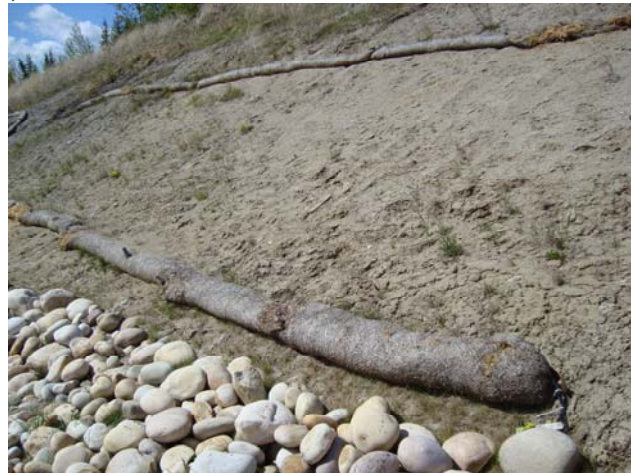
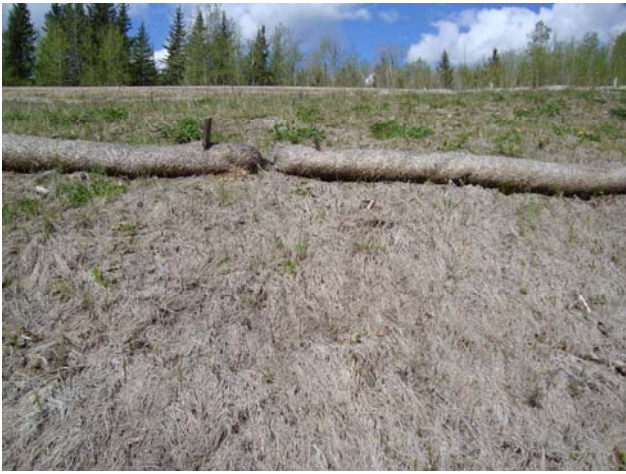
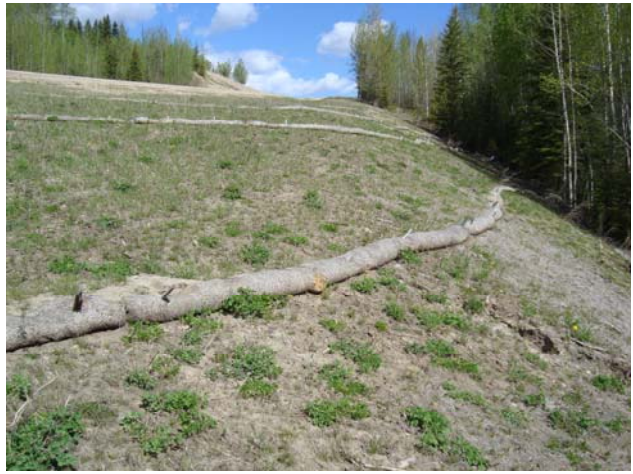
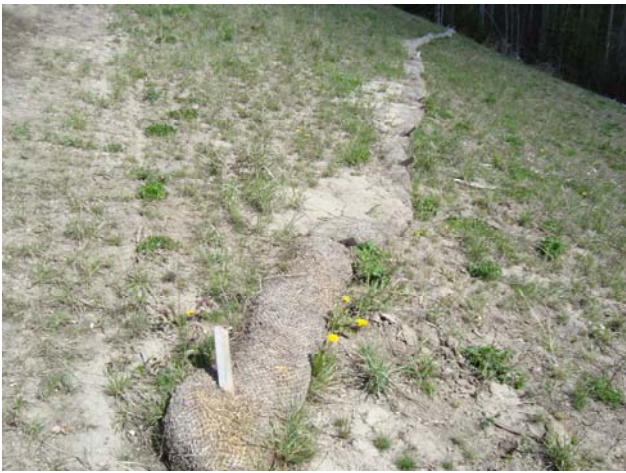
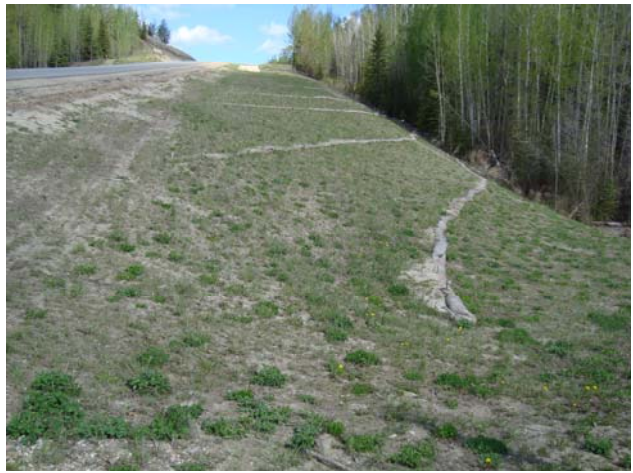
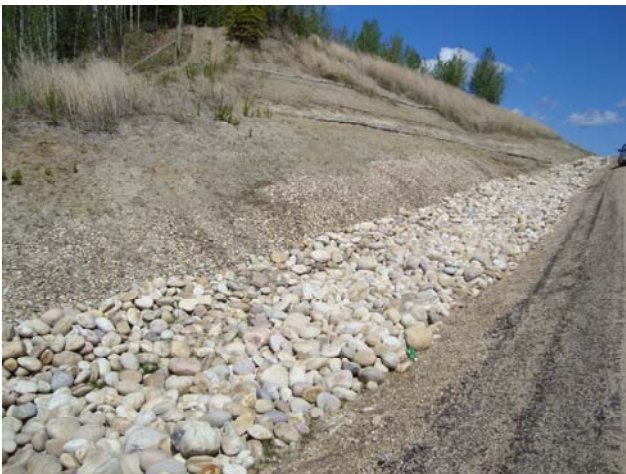
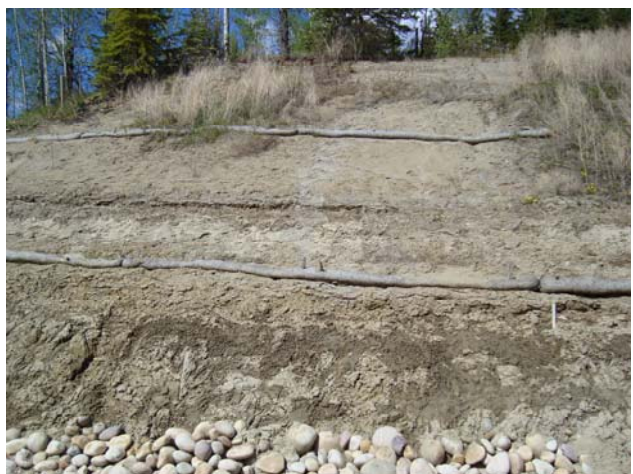
Stenlog was installed on the back and down slopes of the road embankment to reduce slope length, reduce runoff velocity and minimize erosion. Road was paved last year. Stenlog was installed longitudinally along the slopes at 2 elevations. A rock ditch was constructed on both sides of the road. The downslope is starting to catch grass. Stenlog is secured to the slope by wood stakes. There is no sign of a trench being dug before placing the Stenlogs. There is a small number of sock damages, however most straw stays inside the sock with little apparent spillage. Silt is collected at some locations. On the whole installation of Stenlogs looks good. There is no substantial rills and gullies formation on the slopes.

Continue evaluate performance at this site. Visit the H750 site. Advance to Trial status.
