# **Geo-Cells**

(Published in the Department TSB Newsletter in June 2003)

## **Construction on Highway 837:02 and Highway 841:02**

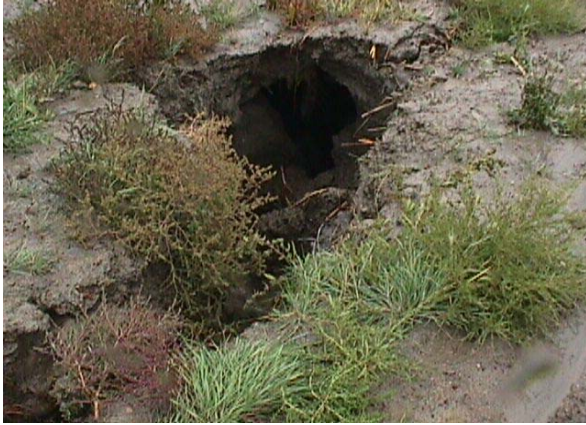
Subterranean erosion channel is formed below the east ditch in Hwy 837:02

Rather than in-filling the erosion gullies as done several times previously, an erosion control design was requested from the consultant. The consultant presented several alternatives, including geo-cell and gabion-lined channels. At Alberta Transportation's request it was decided to pursue the geo-cell alternative at a trial site since the department had no experience with geo-cell technology. If geo-cells turn out to be a successful alternative to gabion channels, the department can install it in other locations with confidence.

Ledcor, the maintenance contractor for the Drumheller area installed the geo-cell in October, 2002, under the supervision of department operations personnel. Construction was quite straightforward. First, the gullies were in-filled, the channels shaped and graded to the design grade and width. Geotextile was laid, the geo-cell extended over the geotextile, and pinned into the channel bed. Gravel was then placed into the geo-cell open matrix, and levelled. Check weirs constructed of gabions were also installed along steeper portions in order that runoff velocity would be further reduced. Gabion baskets and ripraps were also placed at the inlets and outlets of culvert pipes to reduce scouring.

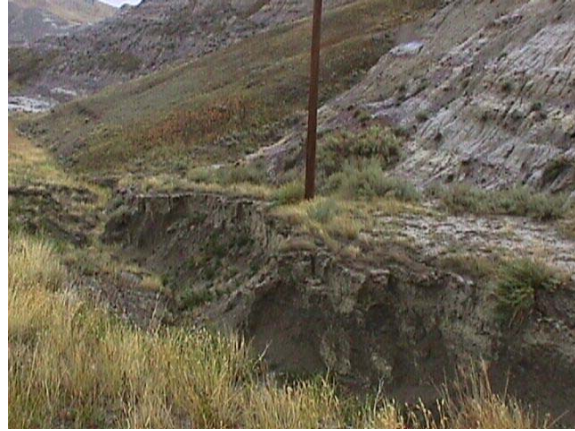
Deep erosion gully is formed in the west ditch in Hwy 841:02

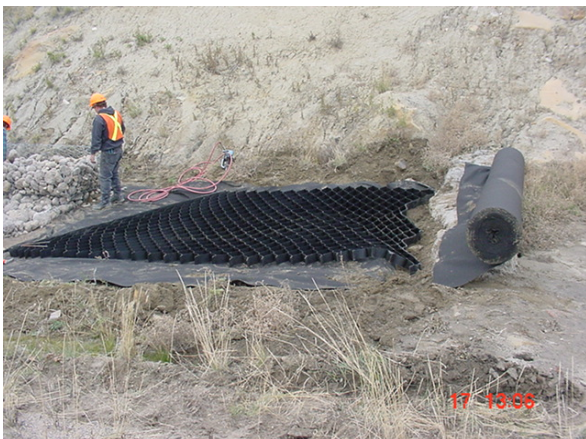
Geo-Cell webs are stretched and laid on geotextile

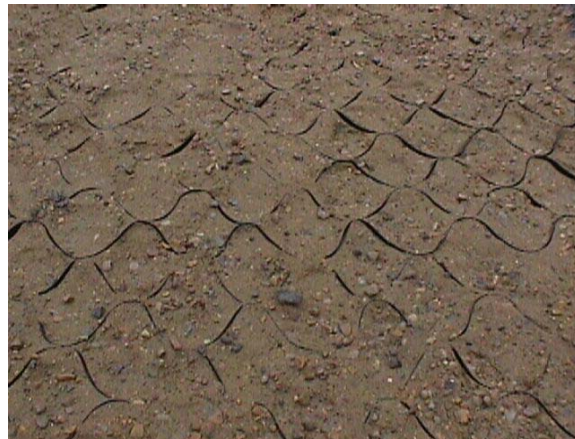
Geo-Cell – filled with gravel and sand and levelled

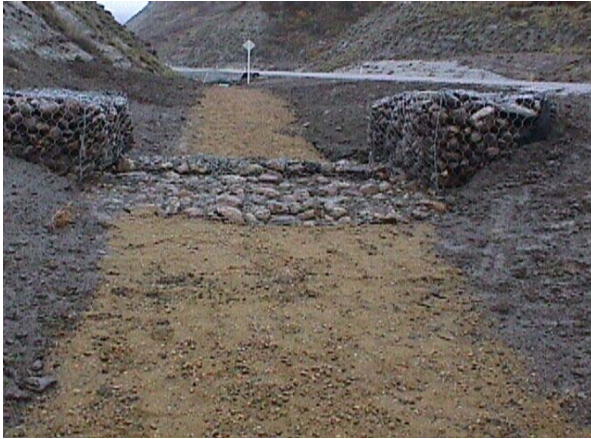
Geo-Cell (brown gravel) channel
