Getting the job done

Trans Canada Highway reopening

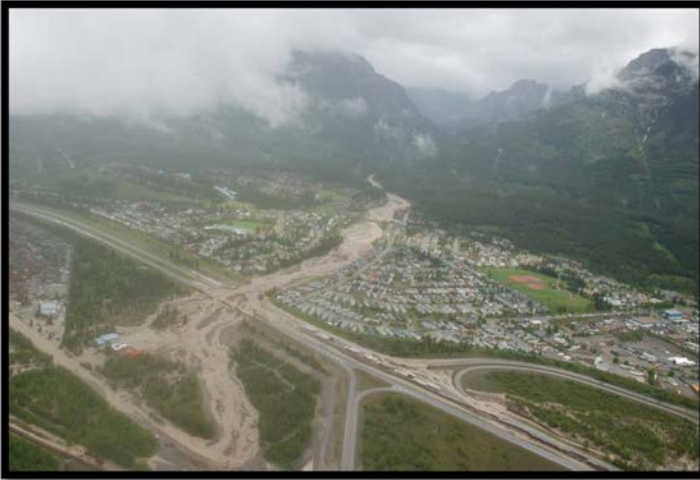
Flood damage at Cougar Creek

With a gaping hole in each direction of the highway just east of the Banff National Park east gates, the road was closed. Crews worked virtually non-stop as soon as the water receded enough to begin repairs and, just six days later, Alberta Transportation Minister Ric McIver reopened the TransCanada Highway. Here's what it took for Volker Stevin to repair the bridges and foundations, clear the culverts and rebuild the roads:

- **140 workers** – 65 on site/75 getting material and equipment to the site
- **13,000 man hours**
- **5,500 equipment hours** – dozens of pieces of equipment hauling material and working on site
- **175,000 cubic metres** of rock backfill
- **850 cubic metres** of boulders to stop erosion
- **135 cubic metres of concrete** poured to stabilize the bridge abutments

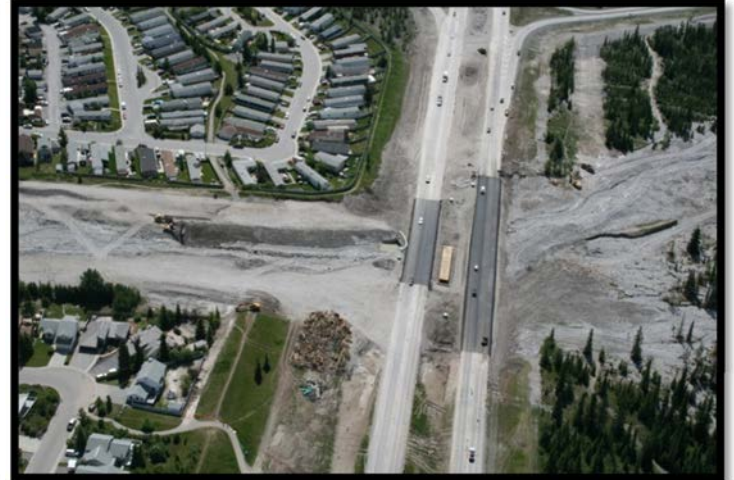
Post-repair at Cougar Creek
