## HD-21A Durable Waterborne Traffic Paint

Location: Hwy. 43 at Fox Creek, Little Smoky and near Valleyview

Applied: June 19 and 20 by Lafrentz

Inspected: February 14, 2007

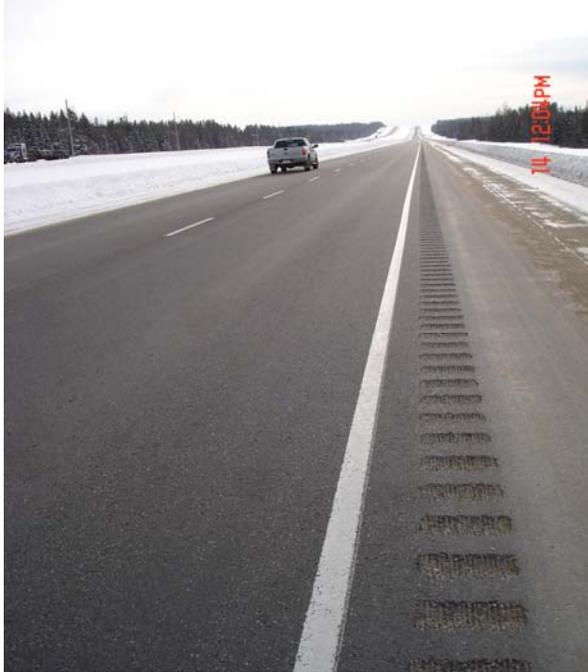
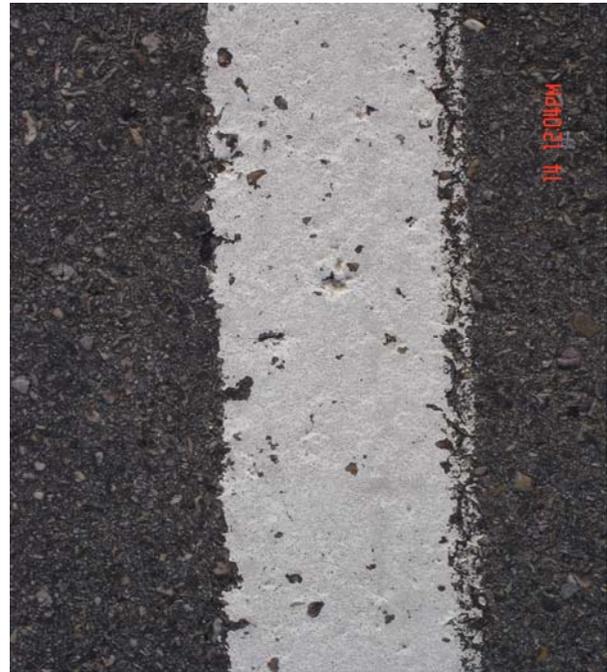
**Rest area approx. 50km south of Valleyview on SBL**

White edge line Retro readings: 53, 56, 58, 48, 57, 58, 68 – **Average: 57**

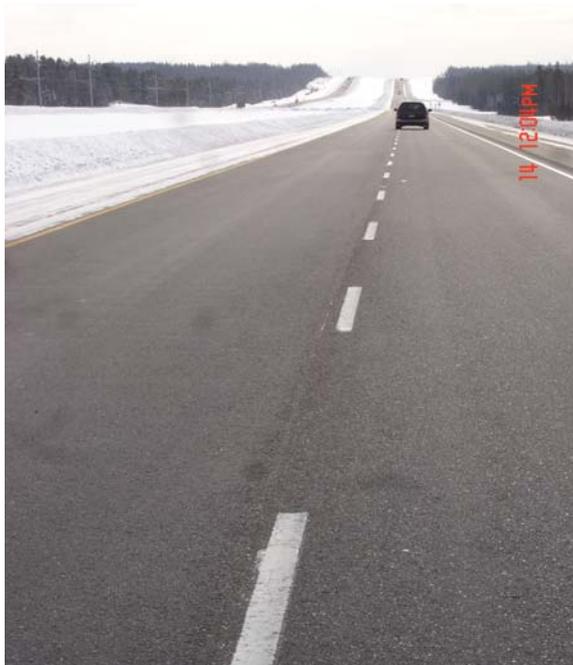
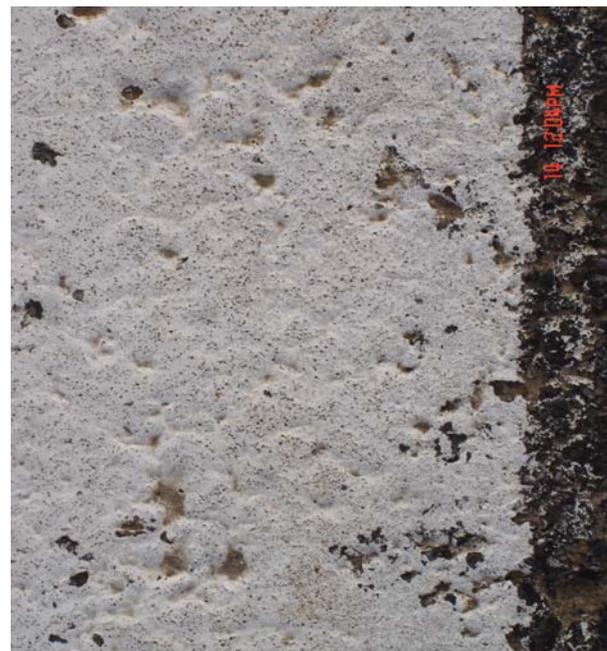
Skip line Retro readings: 113, 108, 98, 91, 97, 94, 105 –

**Average: 101**

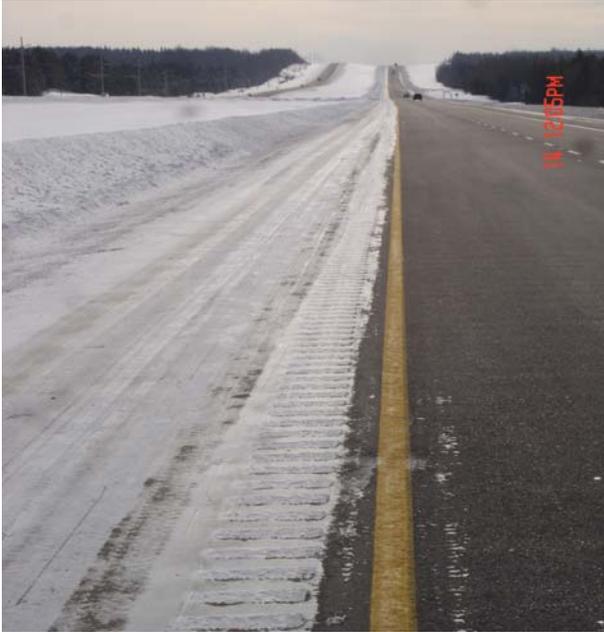
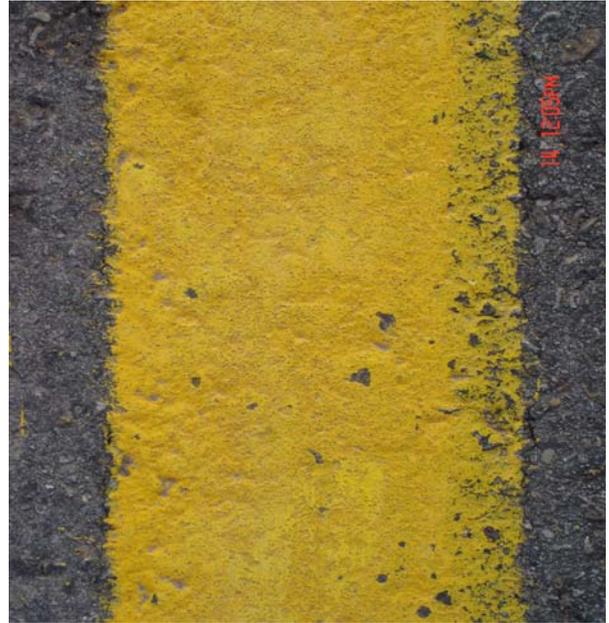
Yellow edge line Retro readings: 44, 41, 42, 50, 53, 44  
Note: readings taken in the middle of the rest area.

**Average: 46**

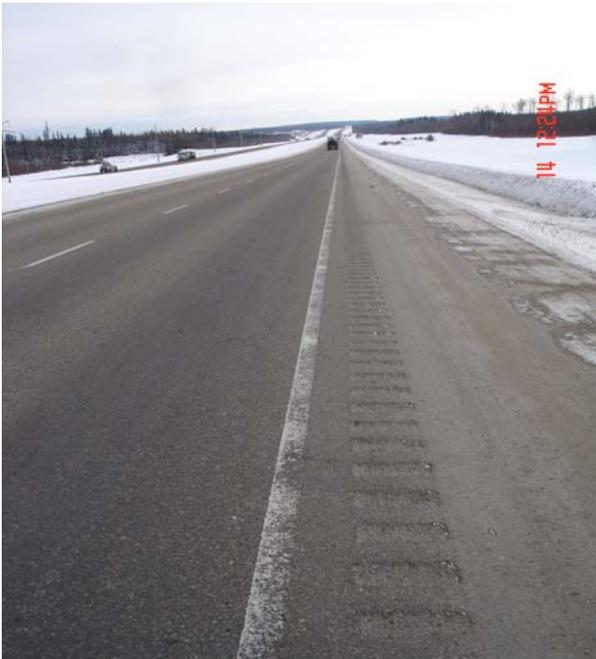
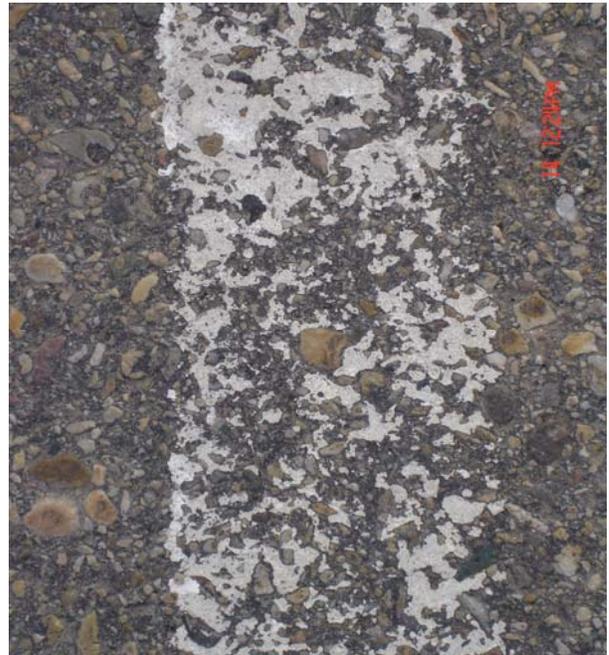
### SBL at the 2km sign to Fox Creek

White edge line Retro readings: 18, 33, 23, 32, 19, 23 – **Average: 25**

Repainting of these lines will be required during this coming spring as the durability and retro-reflection on most of this stretch of roadway is not acceptable.

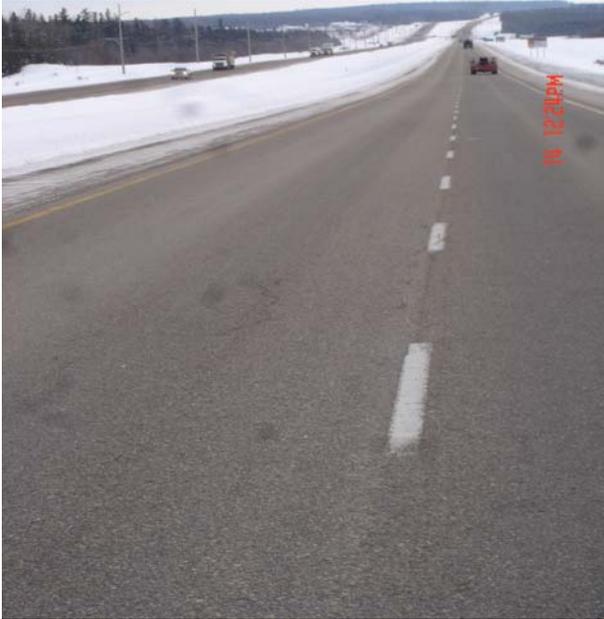
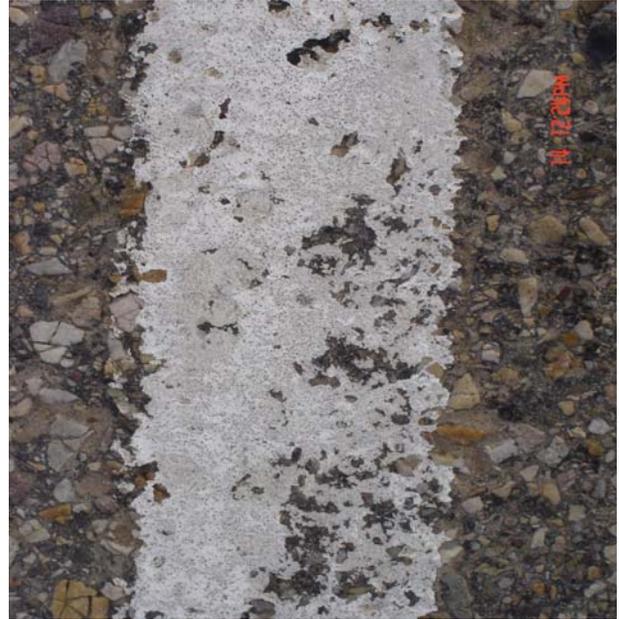
Skip line Retro readings: 41, 57, 59, 33, 45, 49

**Average: 47**

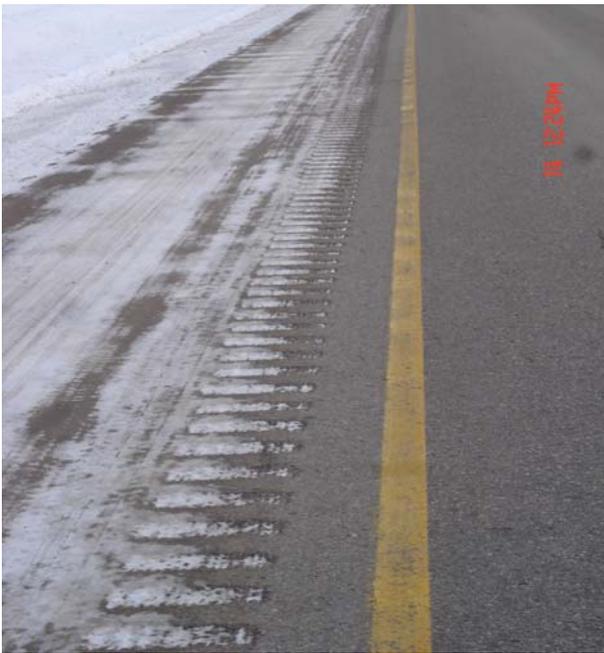
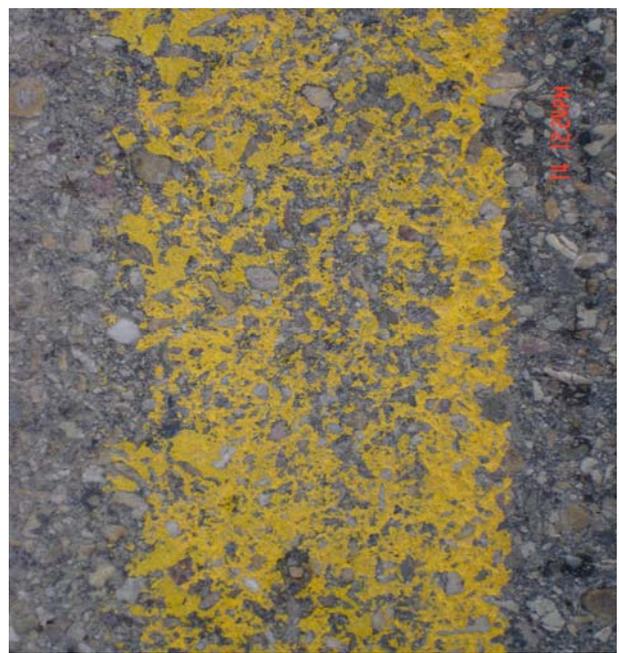
Yellow edge line Retro readings: 23, 22, 31, 29, 27, 24, 25, 22 –

**Average: 30**

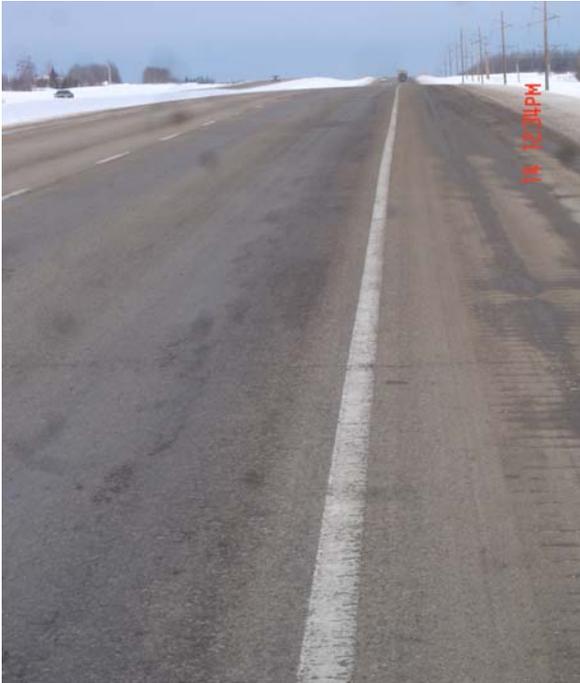
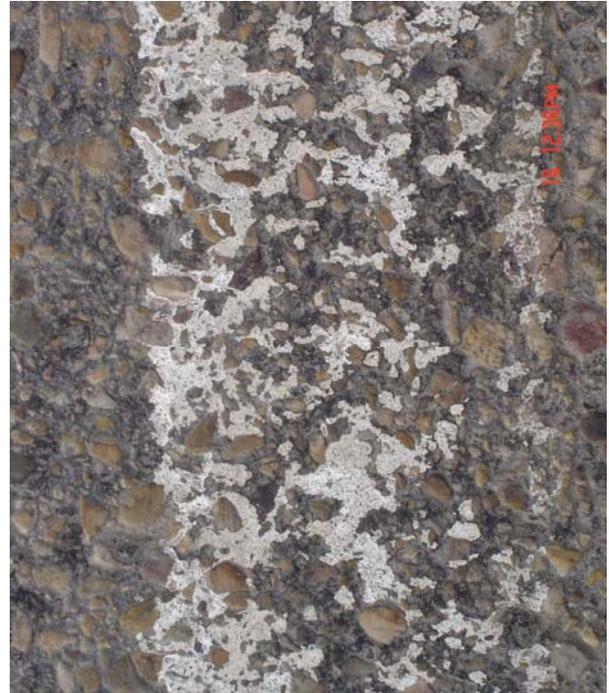
**NBL - opposite the 2km sign to Fox Creek on the SBL**

White edge line Retro readings: 11, 12, 15, 19, 16, 18, 17 – **Average: 15**

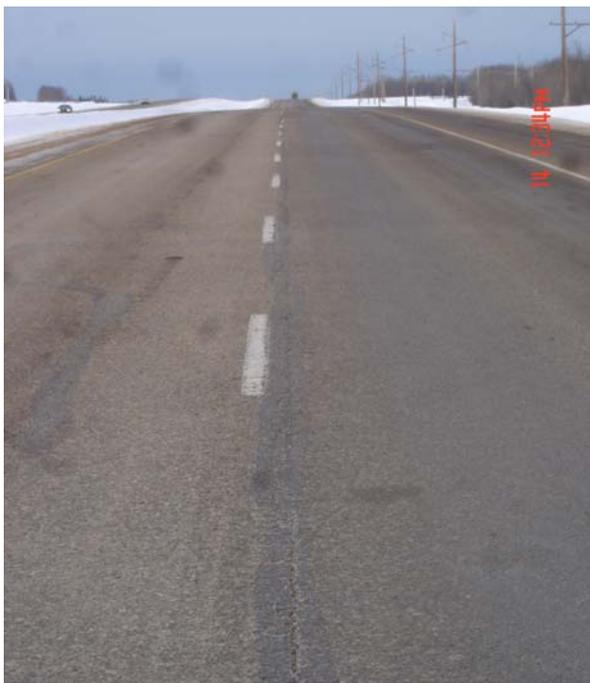
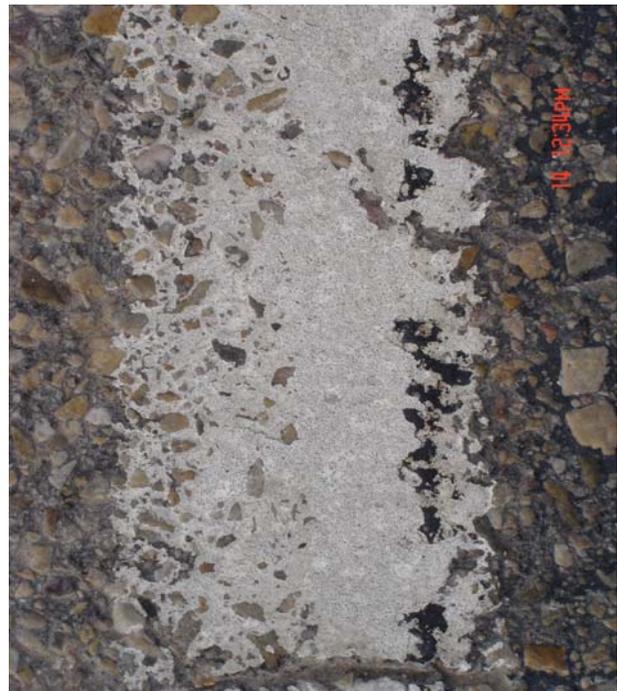
Skip line Retro readings: 32, 29, 32, 19, 30, 31 – **Average: 29**

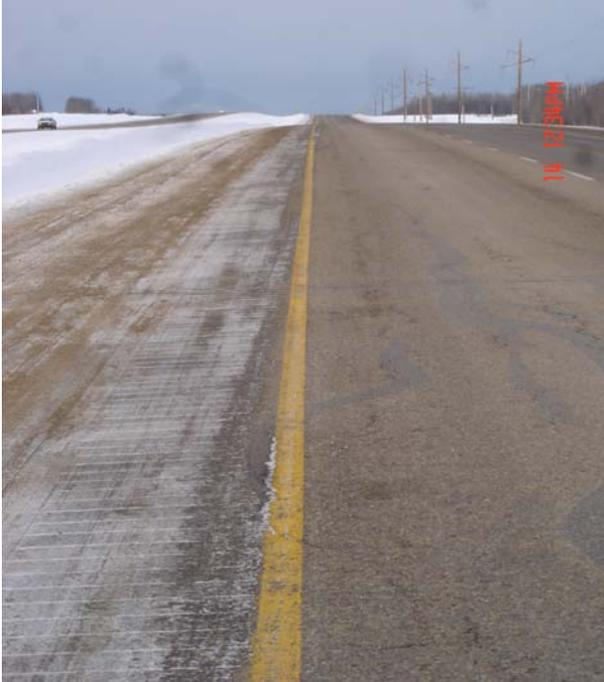
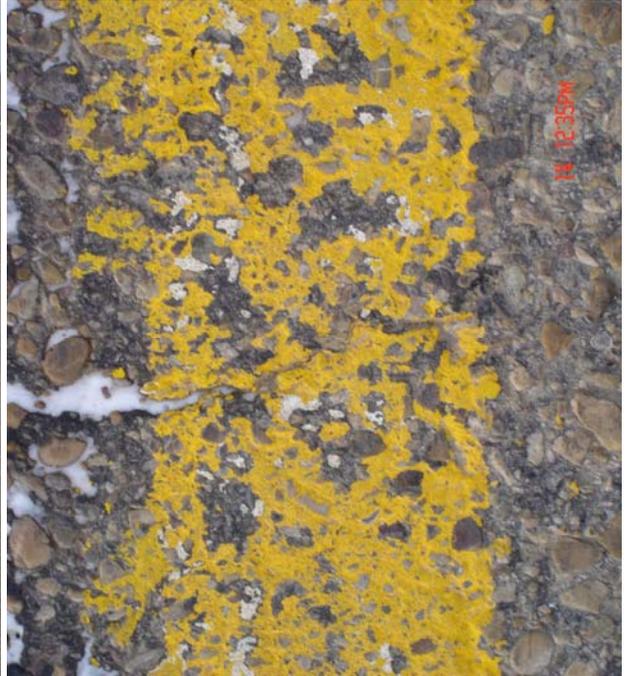
Yellow edge line Retro readings: 20, 21, 22, 24, 23, 24, 21 – **Average: 22**

The HD-21A Durable Waterborne paint system appears to look good in some of the areas of highway 43. However, there are some bad areas where the paint has worn badly. The retro-reflection readings are very low, therefore night time reflectance would be a problem.
